Dobrivoje Ćatić¹ Milan Vasić Jasna Glišović

ANALYSIS OF THE FAULT TREE OF THE CROP SPRAYER PUMP

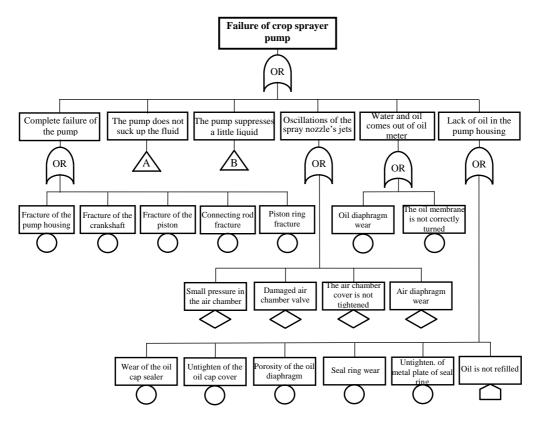
Figure 4. Fault tree of the crop sprayer pump

In order to record the potential ways of failure of the elements of the crop sprayer pump, the manufacturer's instructions for handling and maintenance have been used (Instruction Manual, 2006; Diaphragm pumps User Manual, 2016). Considering the individual failure ways of the crop sprayer pump elements, it can be determined that all causal events that lead to the top event can be classified into 6 subordinate indirect events (Figure 4): complete failure of the pump, the pump does not suck up the fluid. the pump suppresses a little fluid, mixture of water and oil comes out of oil meter, oscillations of the spray nozzle's jets and lack of oil in the pump housing.

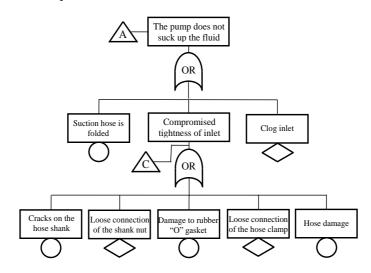
Figure 5. Independent fault sub-tree for the event "Pump does not suck up the fluid"

in the form of an independent sub-tree given in Figure 5. This event can occur if the suction hose is folded or there is a compromised tightness of the supply section of the pump installation or a clog inlet has occurred. Compromised tightness of the working fluid supply can occur due to the occurrence of cracks on the hose shank, loose connections of the shank nut, damage to the rubber "O" gasket, loose connections of the hose clamp or damage to the hose. The clogged fluid supply may occur if there is no filter for cleaning or there is a filter strain, so that the shavings, impurities and residue from the fluid reservoir flow smoothly and reduce the flow of the suction line.
