SERBIATRIB '19

16th International Conference on
Tribology

TRIBOLOGICAL IMPLICATIONS OF THP MODULARIZATION

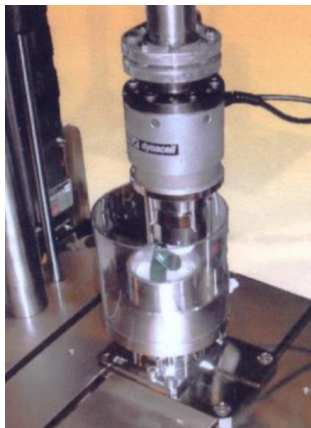
The fretting tests were performed on an Instron® device (Fig. 1) which simulates fatigue loading of a hip cemented stem during a walking cycle. It is installed on a MTS® Bionix multi-axial dynamic servo-hydraulic testing machine [19], equipped with a hip implants testing system.

Figure 1. Instron® fatigue testing device of total hip prosthesis

The device is mounted in a sealed chamber containing saline solution with a high concentration of sodium chloride (~ 0.2 M) at a temperature of 38 °C. The assembly has a temperature regulator and a circulation pump for in vivo testing. Flexible holder for the prosthetic stem allows testing of a large variety of hip prostheses stem geometries, offset angles, and materials. The device applies compressive, bending and torsional stresses to meet ISO 7206-4 requirements.

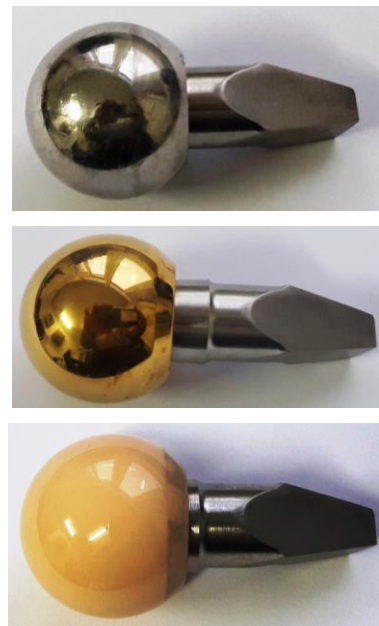
analysed different couplings of the Kinectiv femoral stems with different neck junctions with the femoral heads. Combining the neck adapters with the three types of femoral heads, resulted six femoral head-femoral neck combinations: Ti6Al4V/Ti6Al4V, Ti6Al4V/CoCr, Ti6Al4V/ceramics, CoCr/Ti6Al4V, CoCr/CoCr, and CoCr/ceramics. Three of the six resulting combinations are shown in Fig. 5.

Figure 5. Femoral head – femoral neck combinations that have been tested

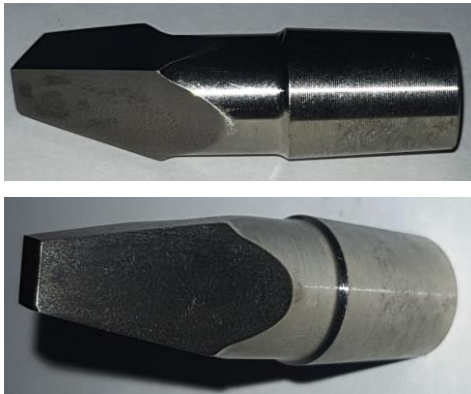
After the tests, the resulting surfaces of the femoral head – femoral neck and femoral stem – femoral neck taper junctions were inspected visually and microscopically. All of these surfaces have shown, to a greater or lesser degree, evidences of fretting wear and fretting corrosion.

Fretting traces were revealed both on the taper and trapezoidal junctions of the femoral neck adapters, as well as inside the conical holes of the femoral heads.

Figs. 6 and 7 show the fretting and corrosion wear images on the surfaces of these junctions.

Figure 6. Taper and trapezoidal junctions of femoral neck adapters in CoCr (a) and Ti6Al4V (b) after 2450000 fretting cycles

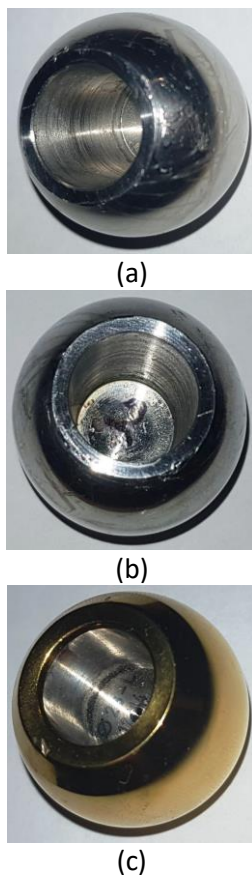
Figure 7. The fretting and corrosion wear of the inner taper of the femoral heads made of CoCr (a), Ti6Al4V (b) and ceramics (c) after 2450000 fretting cycles
