# REHABILITATION OF DAMAGED FLAT SLAB USING FIBER REINFORCED POLYMERS FRPS

Hafssa Ali Abdullah<sup>1</sup>  
Haider Turki Abed  
Abdulla Saeb Tais

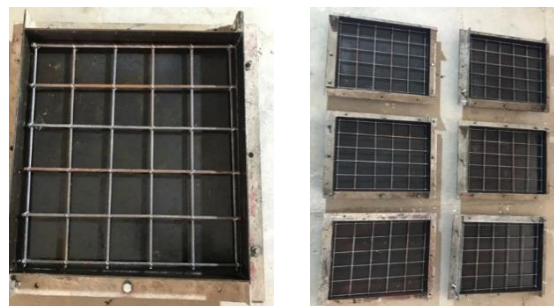
Six panels of bidirectional Reinforced Concrete (RC) plate are shown in Figure 1, with dimensions of length 500 mm, width 500 mm, and thickness 50 mm, which were cast, externally modified, and statically tested under single-point loading.

**Figure 1.** Bidirectional RC plate

The performance of FRPs in enhancing the ultimate bending capacity of reinforced concrete slabs was inspected. Reinforcing steel bars with a diameter of 6 mm were used for internal reinforcement, and the distance between the bars was 80 mm in the longitudinal direction and 80 mm in the transverse direction and a 25 mm thick concrete cover was used. The rebar is closer to the top in the direction of tension.

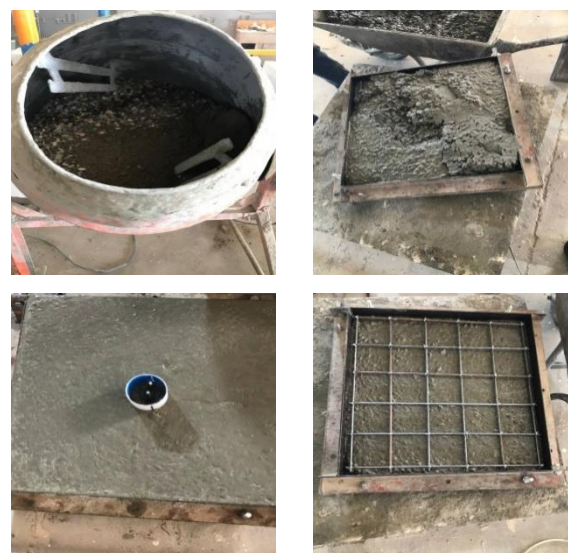
All trial mixes were conducted in a 0.1 m<sup>3</sup> capacity rotary mixer. Figure 2 shows the process for preparing the specimens.

**Figure 2.** The process of preparing the specimens.

The mixing procedures involved setting the aggregate in the mixer, where fine aggregate was added to the mixer, followed by spinning the mixer. Then the cement was incorporated into the mixture, and gradually water

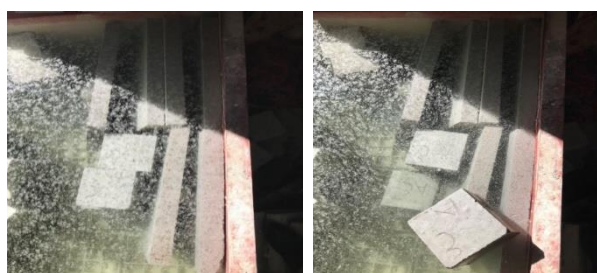
Precipitation was acceptable, and the consistency of the concrete was good and suitable for the pouring process. After completing the casting process, the models were cured for 28 days, as shown in Figure 4.

**Figure 4.** Processing forms.

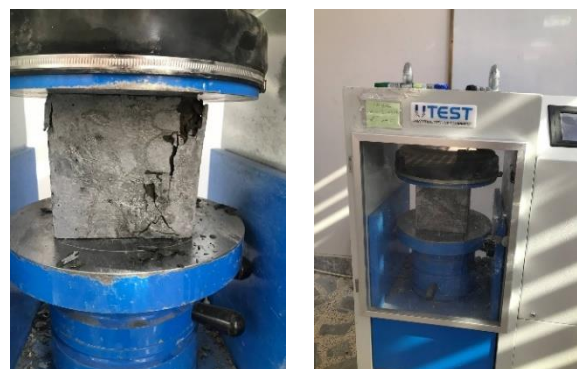
Compression test on 7-day-old and 28-day-old concrete cubes to determine the bearing capacity of the concrete, as shown in Table 5 and Figure 7.

**Figure 7.** The compressive strength cubes

The comparison between concrete cubes aged seven days and twenty-eight days. The average resistance percentage for cubes was seven days old, 33.5033 MPa, and the average resistance percentage for cubes was twenty-eight days old, 40.5 MPa. The resistance rate of the cubes at the age of seven was 82.7% of the resistance rate at the age of twenty-eight days, and this is considered good concrete and suitable for use.
