# INFLUENCE OF FRACTURING ON SLOPE STABILITY

## ABSTRACT

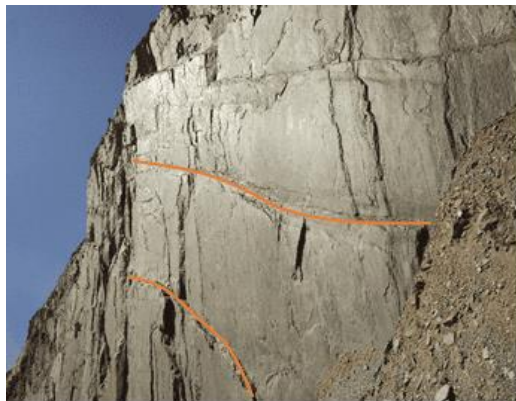
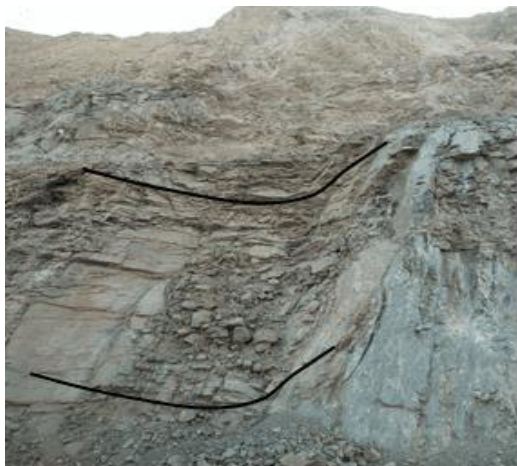
**Figure 7.** Examples of planar and wedge failures in M'HAUDATT pit: (a) Planar failure on the M'HAUDATT pit footwall; (b) Wedge

The footwall of the M'HAUDATT pit exhibits several intersections of discontinuity planes that run parallel to the pit slope, as shown in Figure 7(a). Based on the projection of the discontinuity structures in the analysis of the pit high wall, it is possible that faces where the intersections of these discontinuity planes daylight in the direction of the pit slope may be unstable, as illustrated in Figure 7(b).
