# SERBIATRIB '19

16<sup>th</sup> International Conference on  
Tribology

## EXPERIMENTAL STUDY OF $\text{MoS}_2$ COATED GEARS TESTED IN VACUUM AFTER EXPOSURE TO HUMIDITY

<sup>2</sup>NASA Glenn Research Center, Cleveland, OH, USA

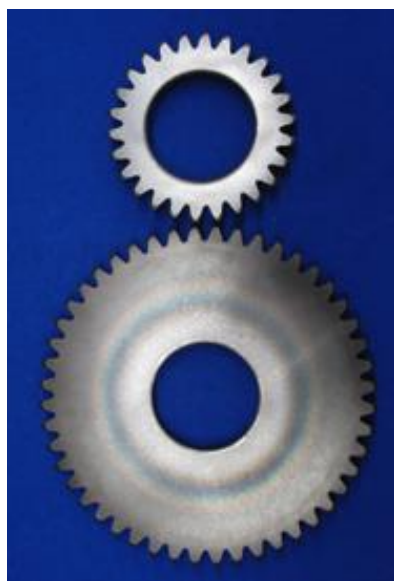
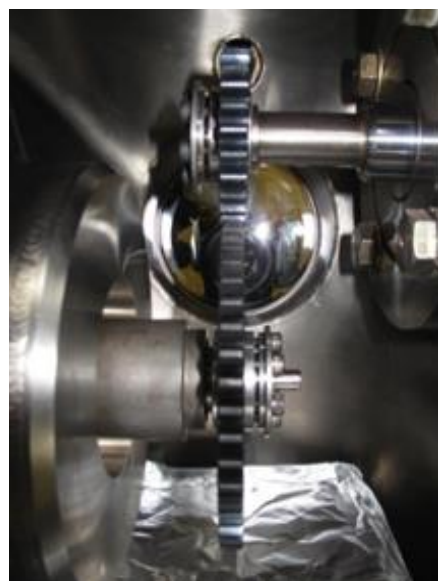
**Figure 3.** Test gears: (a) Just prior to testing, (b) Installed in rig just prior to closing test chamber.

As the test sequence progressed, it was decided that photo documentation of the conditions of the teeth prior to testing might prove insightful. Beginning with the fifth test in the testing order sequence (test MoS<sub>2</sub> 4-A, per Table 1), the first step of the testing sequence was to document the visual condition of each gear with digital photographs. Next, the gear pair was mounted onto the test rig shafts, and then the chamber vacuum condition was established over several hours (typically overnight). The chamber pressure was  $7 \times 10^{-7}$  Torr or less at the beginning of each test. Figure 3 shows a pair of the MoS<sub>2</sub> coated test gears out of sealed bags just prior to test, and in the test chamber just prior to closing the vacuum chamber door for testing.

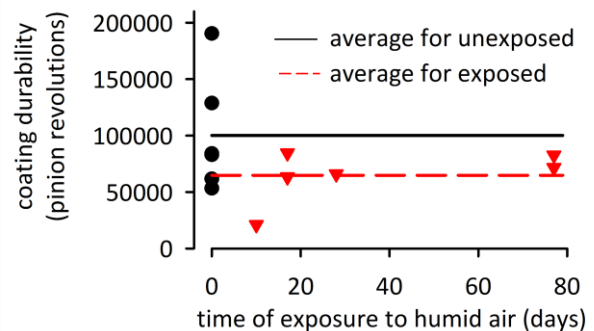
**Figure 5.** Film durability as function of time of exposure to humid air.

The film durability values, from the "Average Value" column of Table 2, are plotted as a function of the duration of exposure to humid air in Figure 5. The plot shows that while as a group the durability was longest for zero days of exposure, there is no

clear trend of rate of reduction with exposure time. The range of scatter of the film durability for six tests at zero time of exposure is greater than the difference between average durability of exposed and unexposed gears.
